Form Number
1116

Historic Name Reuben & Edith Mead House

BUILDING FORM (47 Robinson Road)

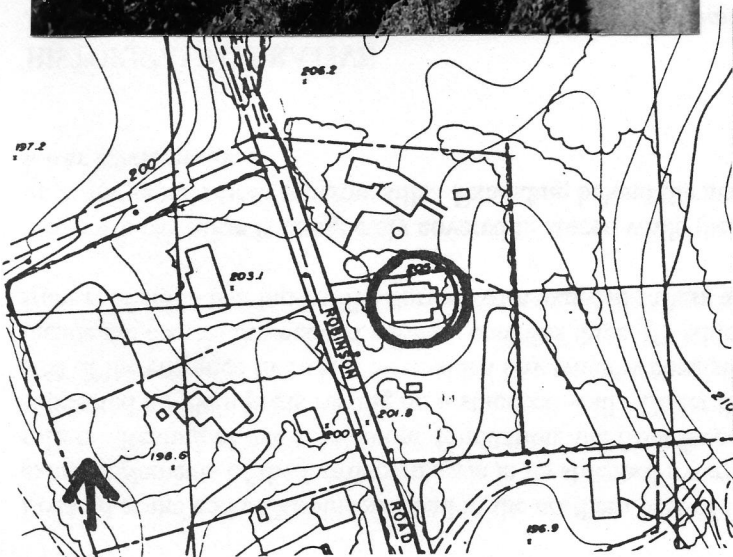
A black and white photograph of a two-story house with a gabled roof, partially obscured by dense foliage and trees. The house has several windows and a small dormer. A paved driveway or path is visible on the right side of the image.

Located at the end of Robinson Road in the northern part of Lexington, 47 Robinson Road is a two-story dwelling which exhibits elements of the Craftsman style in its stuccoed exterior and its slate hip roof with overhanging eaves and exposed rafters. Resting above a fieldstone foundation, the front facade is three bays wide and is fronted by a single-story porch supported by plain posts resting on a stuccoed wall. Under the porch, the center entrance is flanked by sidelights. On either side of the entrance there is a three-sided bay window consisting of a 8/1 sash flanked by 6/1. On the second story of the facade the central three-sided window contains three 4/1 windows with an individual 8/1 sash on either side. Centered on the front roof slope is a hip-roofed dormer with exposed rafters and containing three small diamond-paned windows.

The north elevation is completely covered in stucco while the south side is partially sheathed in wood shingles which extend up to the second floor window sills. Extending behind the main house block is a two-story, wood-shingled addition with a lower level garage.
